REGISTRATION CERTIFICATE 307/4 - Annual Report 2012

**Leak Detection and
Repair Program
Cape Town Refinery
Annual Report – 2012**

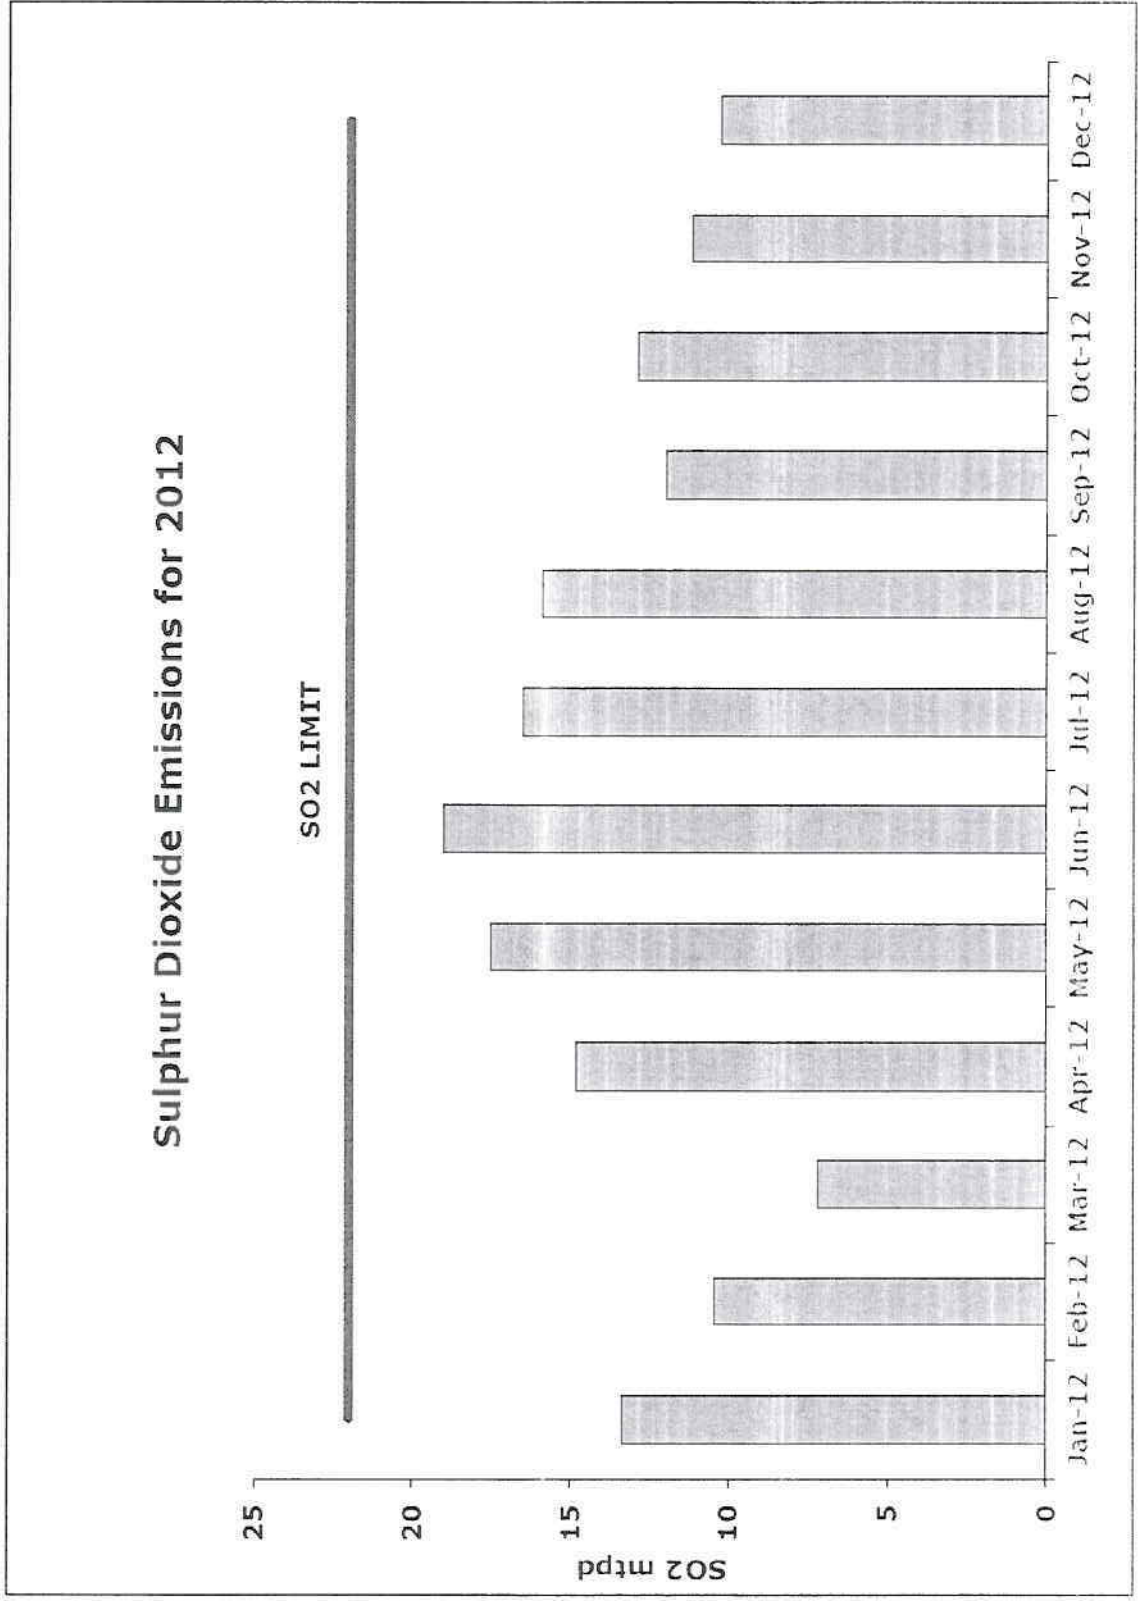
ATTACHMENT 2:

Attachment 2 contains the average monthly SO₂ in metric tonnes per day for 2012.

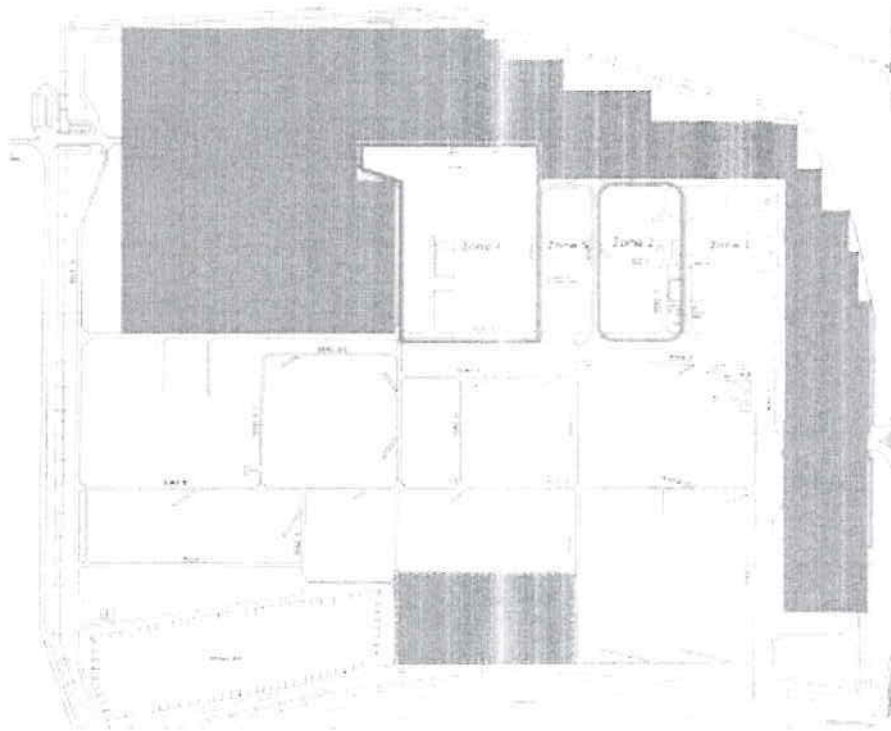
As shown in Figure 1 below, the refinery is split into four operating Zones. Each zone consists of a number of processing units.

Figure 1: Schematic drawing of refinery highlighting each operating zone.
